**MEMO TO:** Prospective Bidders  
**FROM:** Kimberly Toon, Purchasing Manager  
**SUBJECT:** **Addendum #1: Blue Street Office Building Renovation**

# **Blue Street Office Building Renovation**

## **LIMITED ASBESTOS INSPECTION REPORT**

Asbestos Inspections, LLC Project # 2026-01-068

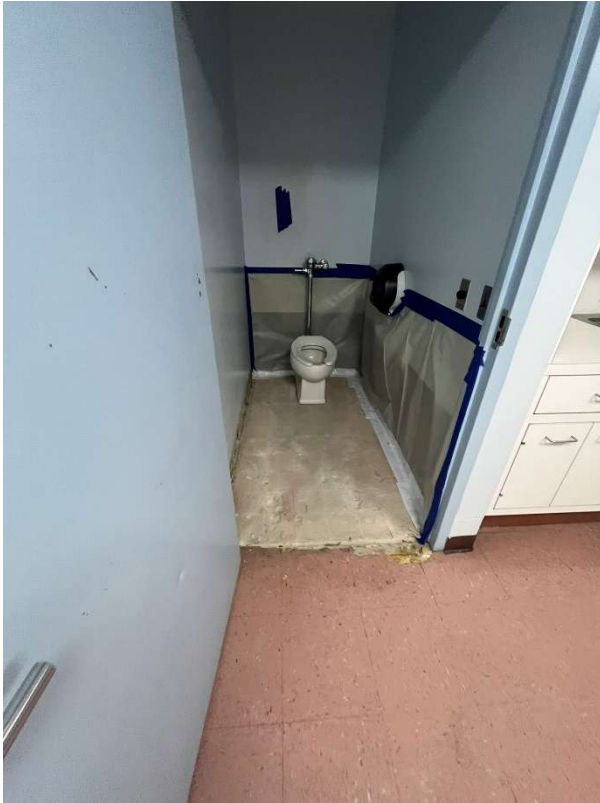
| Sample # | Material | Sample Location | % | Mineral Type | Regulatory Result | Analysis Type |
|---|---|---|---|---|---|---|
| 001A | Dark Pink, Beige Floor Tile | Bathroom | ND | ND | Tested Negative by Lab | PLM |

Interior, Bathroom

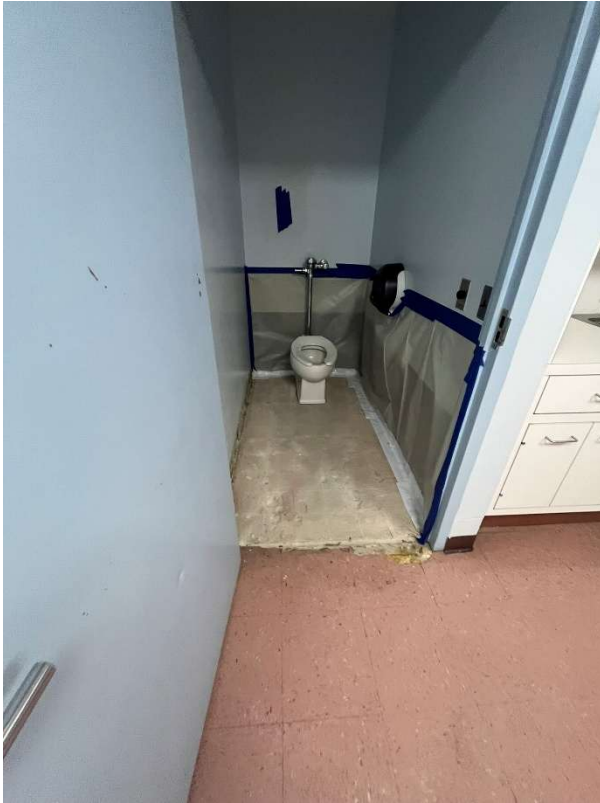
Interior, Bathroom
